# FACILITY COMPLIANCE INSPECTION REPORT

## Division of Waste Management Solid Waste Section

Metro Energy Corporation Scrap Tire Collection and Processing Facility  
 3313 Bowers Store Road  
 Silk Hope, NC 27344

Comprehensive Inspection

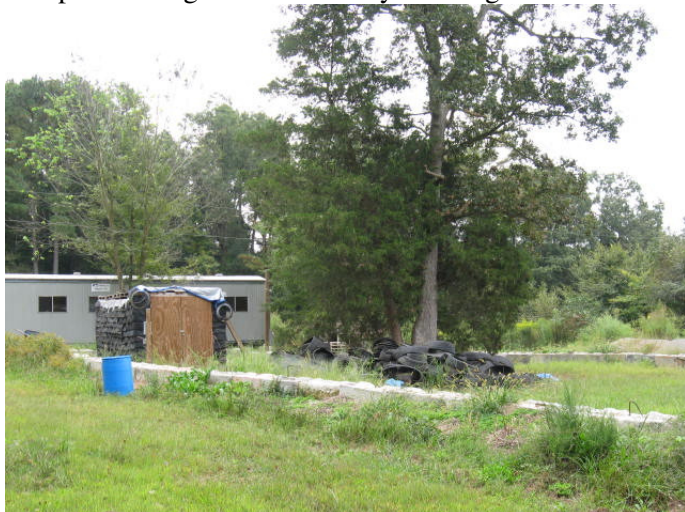
20. The facility has constructed a utility building in the scrap tire storage area. Mr. Tucker stated that the building is used to store hand tools for cutting scrap tires and that the scrap tires used (in its fabrication) equate to  $\sim 20$  scrap tires. It is suggested that the utility building be relocated.

Scrap tire storage area and utility building

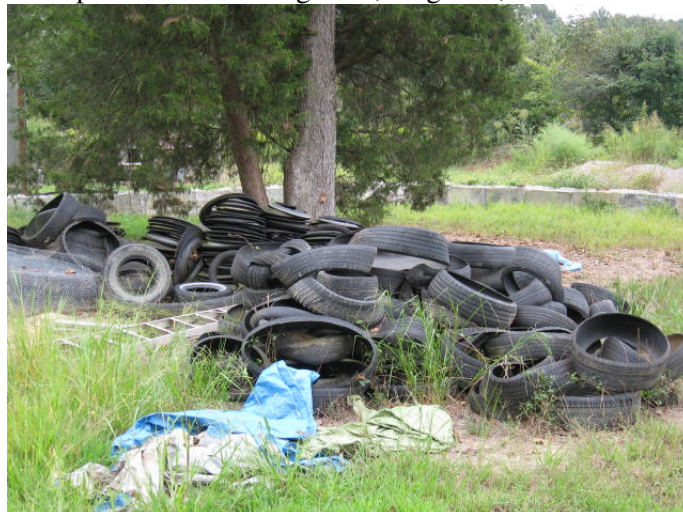
11. The facility is permitted to manually produce cut tires. See file copy letter dated March 18, 2011.
12. Two whole scrap tires were observed in the scrap tire storage area/on site. There were three small piles of processed tires (doughnuts, alligators, and sidewalls) in the scrap tire storage area.

scrap tires cut into doughnuts, alligators, and sidewalls

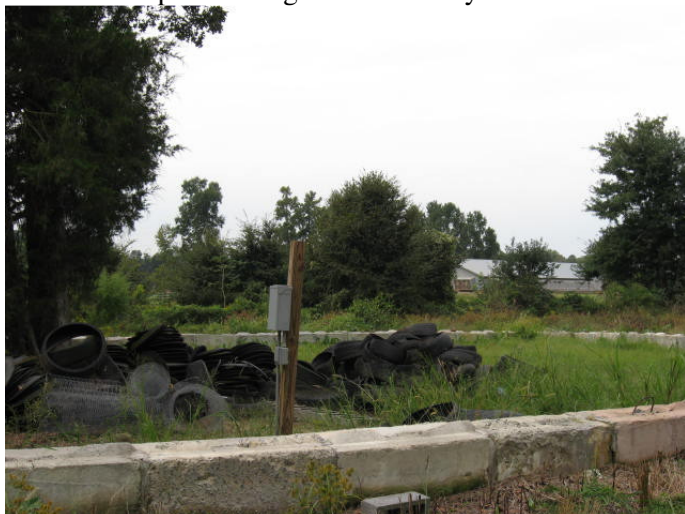
9. Ensure the scrap tire storage area is kept free of grass, underbrush, and other potentially flammable vegetation at all times.
10. At the time of the inspection there was grass in the scrap tire storage area. Mr. Tucker stated that grass grows in the scrap tire storage area although he repeatedly kills it. And that he will apply chemicals to kill it again.

Grass in scrap tire storage area – facility to address

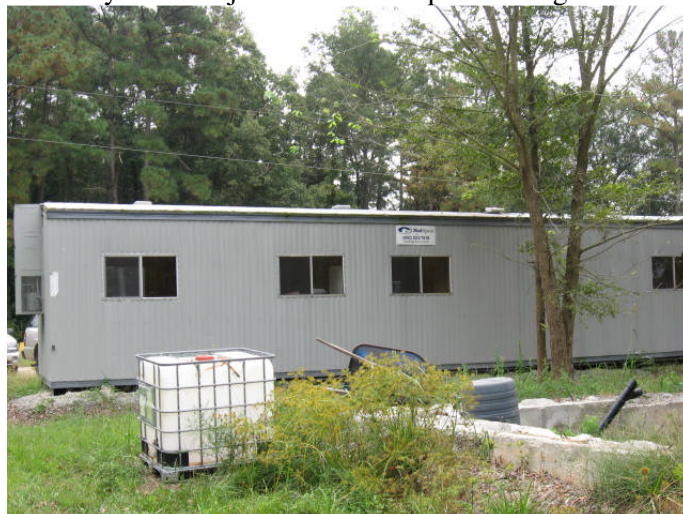
18. Ensure the required buffer is free of obstructive material(s).
19. The facility office appears to be within the required 50' scrap tire buffer area.

Facility office adjacent to the scrap tire storage area
